Ocean Towers South - Structural Milestone Inspection

2023 Inspection Report
WJE No. 2021.3595.2

Concrete Balcony Assessment

July 23, 2021
WJE No. 2021.3595

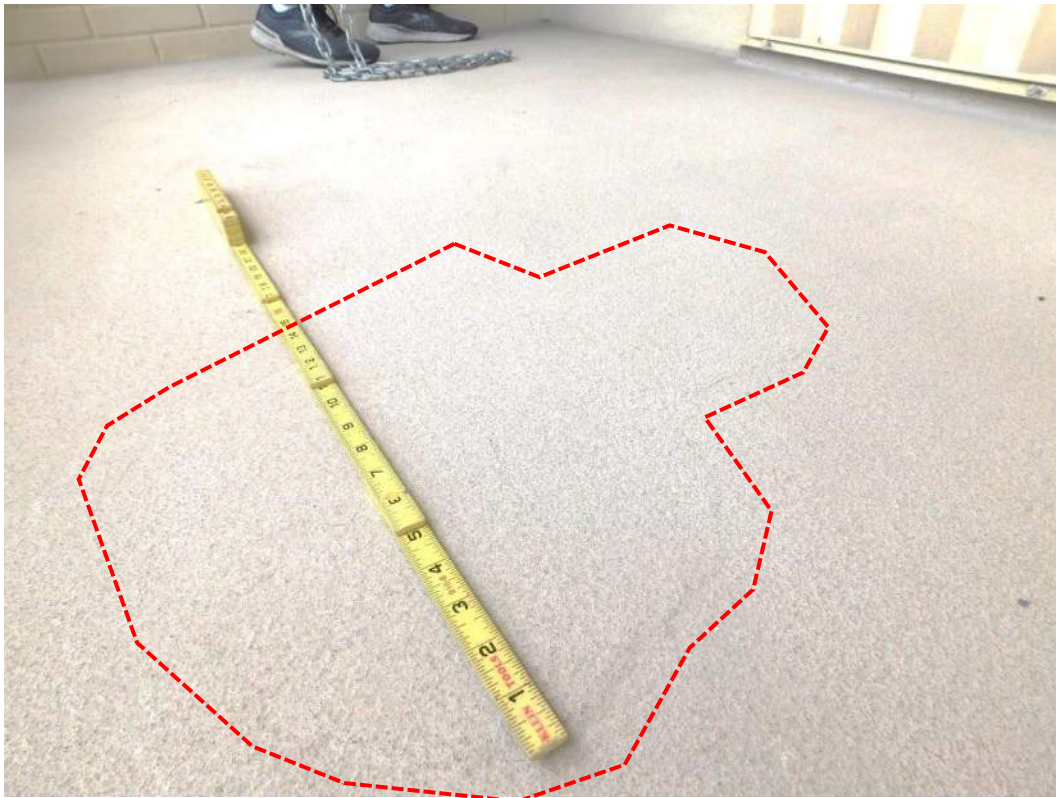
- When sounded, the delaminations produced an acoustical response typical of shallow near surface delaminations.
- Approximately 88 instances of near surface delamination were observed, totaling approximately 128 sq. ft (average of approximately 1.5 sq. ft. per occurrence), on the underside portions of the balconies (soffits) across all levels surveyed, including the soffit of the roof overhand above the Fourth Floor

Based on the observed conditions and the location of the building, the most common/likely deterioration mechanism that would cause the observed delaminations is corrosion of the embedded reinforcing steel. The corrosion of steel is an electrochemical reaction that results in the formation of an iron oxide byproduct. When reinforcing steel corrodes it will expand reaching up to approximately ten times its original volume. This expansion induces stresses due to confinement of the reinforcing steel by the surrounding concrete. The stresses result in cracking of the surrounding concrete in a plane parallel to the concrete surface (known as a delamination). Delaminations that break away from the concrete substrate produce spalling.

Figure 8. Concrete delamination

The concrete distress observed on the balcony slabs (shallow delaminations) can be appropriately mitigated using conventional partial depth concrete repair procedures. While WJE did not identify distress concrete conditions that warrant immediate action (repair, shoring, etc.), consideration should be given to the following repair/maintenance approaches.

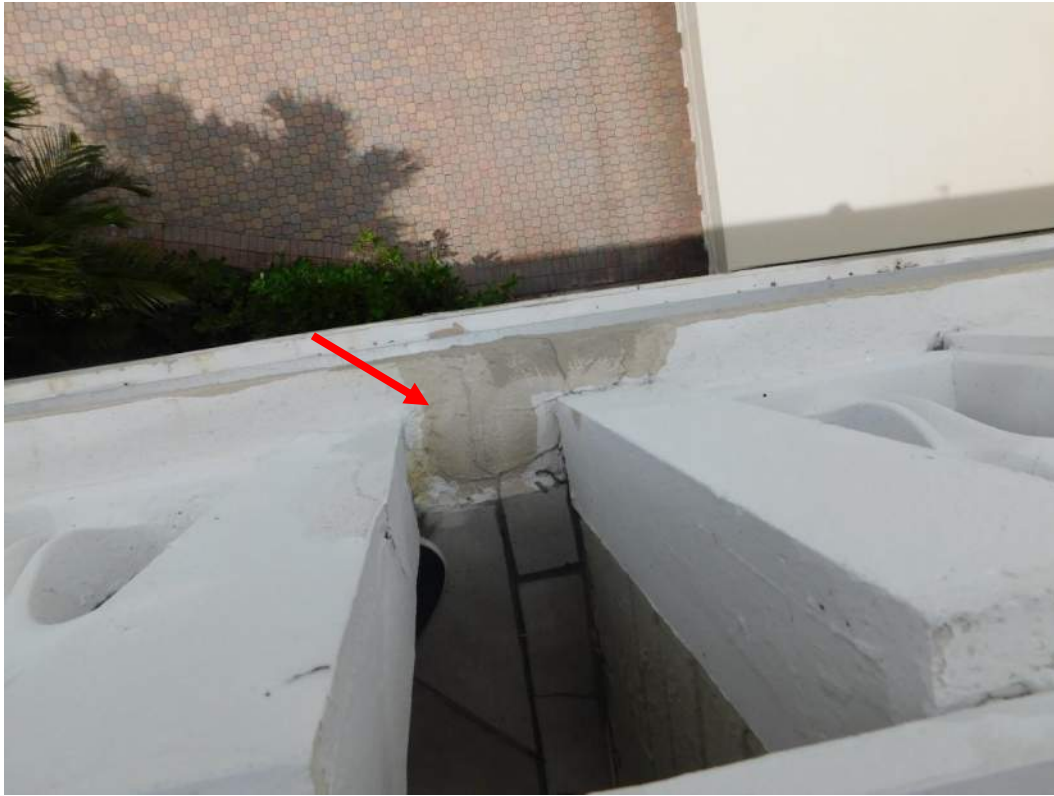
- Approximately 80% of the delamination observed was located on the south side of the building.
- Some of the observed delaminations occurred within unsound previous repairs (Figure 9).

Figure 9. Unsound previous repair

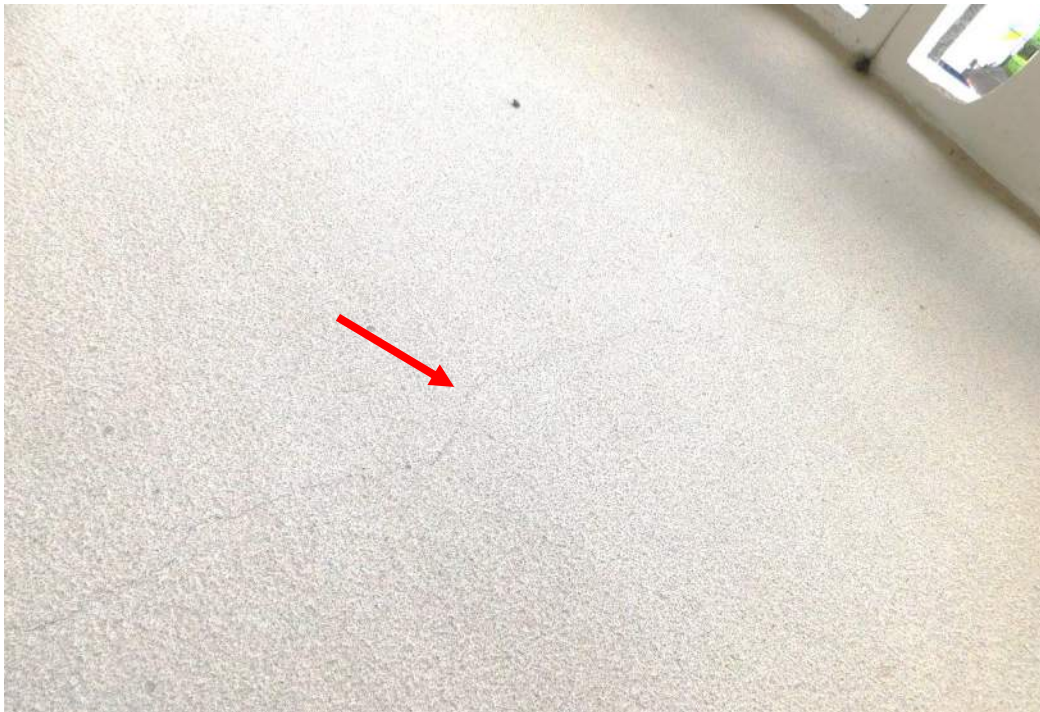
- One instance of corrosion staining totaling 1 sq. ft was detected on the North side of the 4th Floor Soffit.
- A few cracks were observed across at sporadic locations through the south balconies. Most cracks were located in exposed portions of walking surfaces and near the balcony slab edges. The observed cracks were general small in width (less than .010 inches), and occurred in various locations, orientations, and lengths (Figure 10)

Figure 10. Balcony slab crack

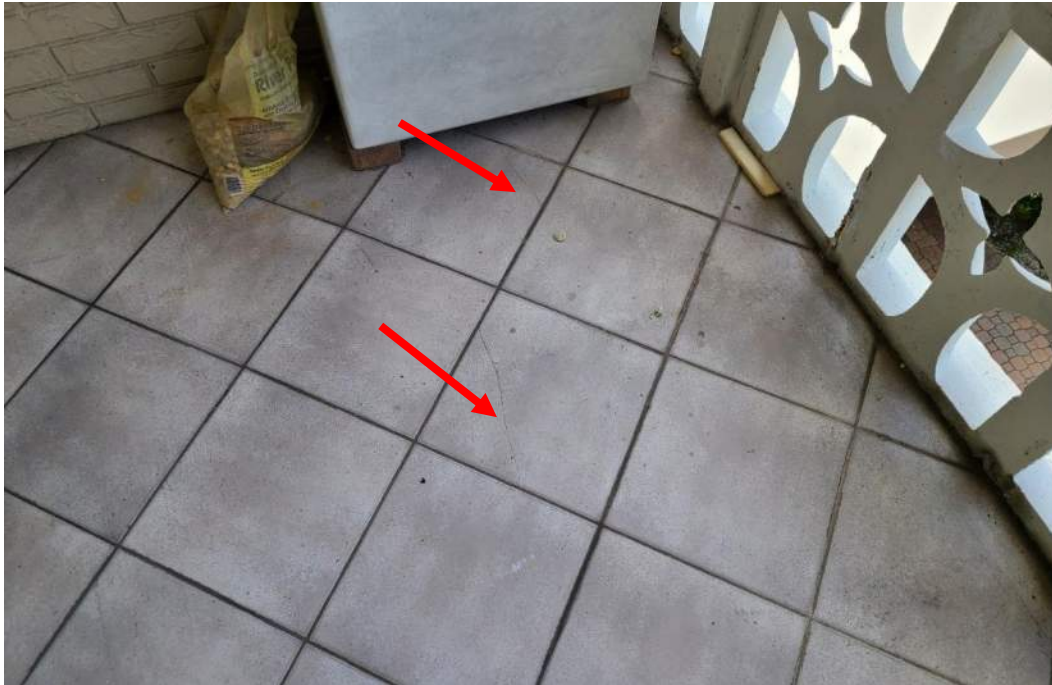
Figure 11. Tile finish cracking

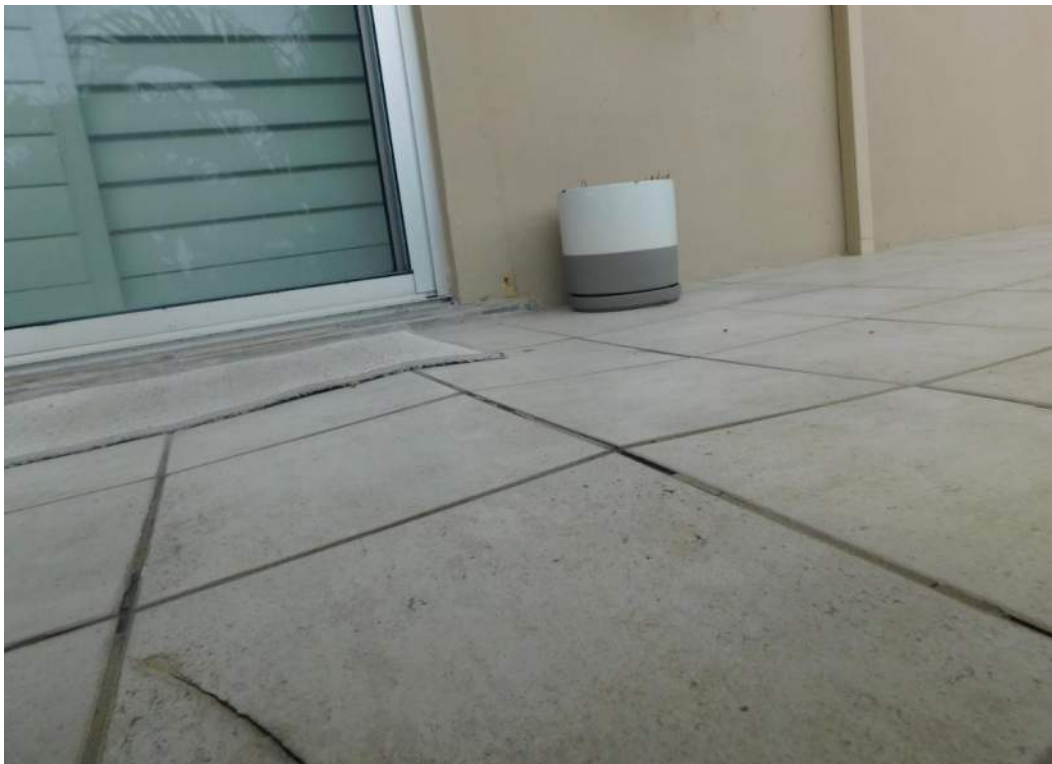
Figure 12. Bowed tile above concrete slab

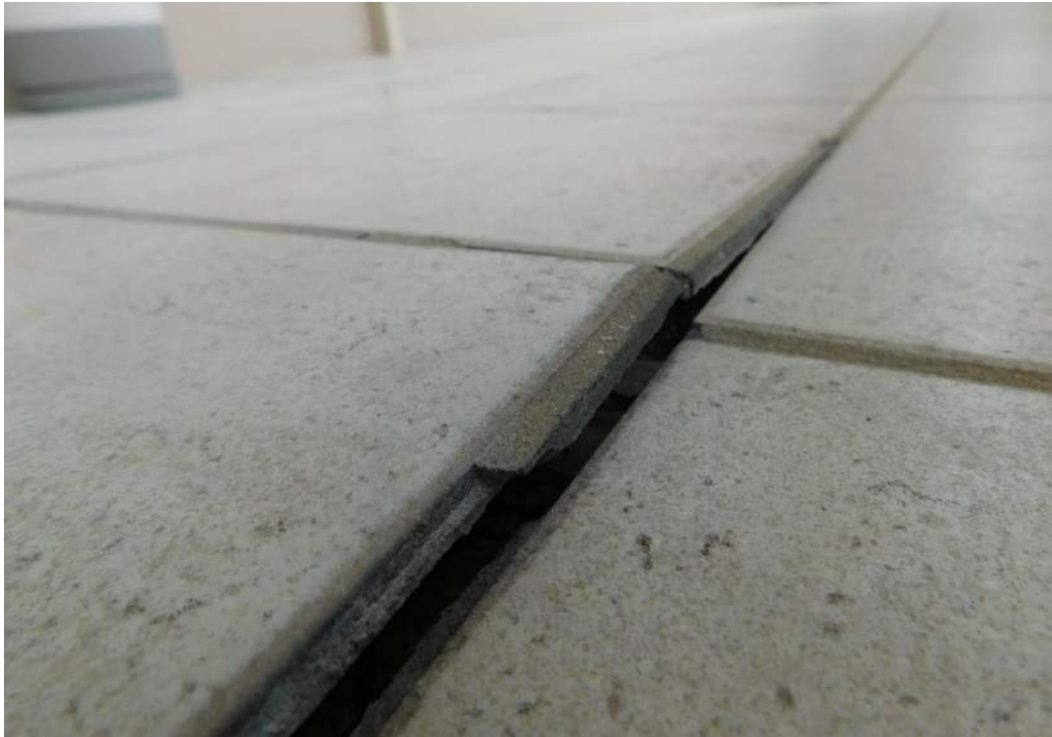
Figure 13. Close-up view of the vertically displaced tile

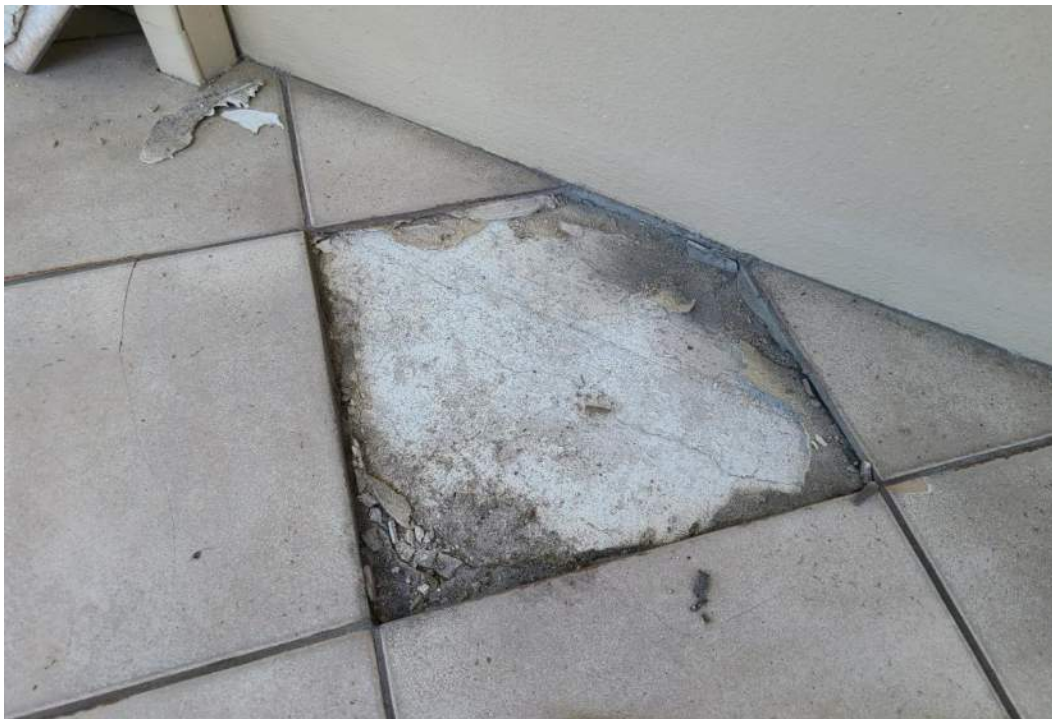
The condition of the concrete present under the various balcony floor finishes is not fully known. Given the observed delamination under the displaced tile and the lack of waterproofing or a protective coating system observed under the one balcony tile removed, it is possible that the concrete under balconies with decorative floor finishes have more extensive concrete deterioration than other locations at the building where a protective coating system is present. The decorative floor finishes present at the building are not inherently waterproof, as water can seep through unsealed tile/stone mortar, perimeter edges, and cracks. While it is not likely that concrete deterioration has caused all of the debonding of the decorative floor finishes observed, it may account for some of the debonding or exacerbate the debonding at some locations. The areas decorative floor finishes (especially where debonded) also present a condition that allows water to be trapped on the concrete surface under the finishes. This trapped water can accelerate the rate of concrete deterioration on the surface of the concrete and can also cause concrete and coating issues on the soffit below. It is important to note that WJE did not identify an appreciable increase in the amount or extent of concrete/coating distress on the soffits of balconies below unbonded (or bonded) decorative floor finishes.

Figure 14. Inspection opening with concrete slab cracking underneath

Given that the condition of the concrete below the floor finishes is unknown, consideration should be given to performing an evaluation of the concrete under these finishes within the next two years. Such an evaluation may include removal (and eventual re-installation) of select tile/stone units from each balcony with floor finishes to visually inspect and sound the concealed concrete. Use of non-destructive testing to

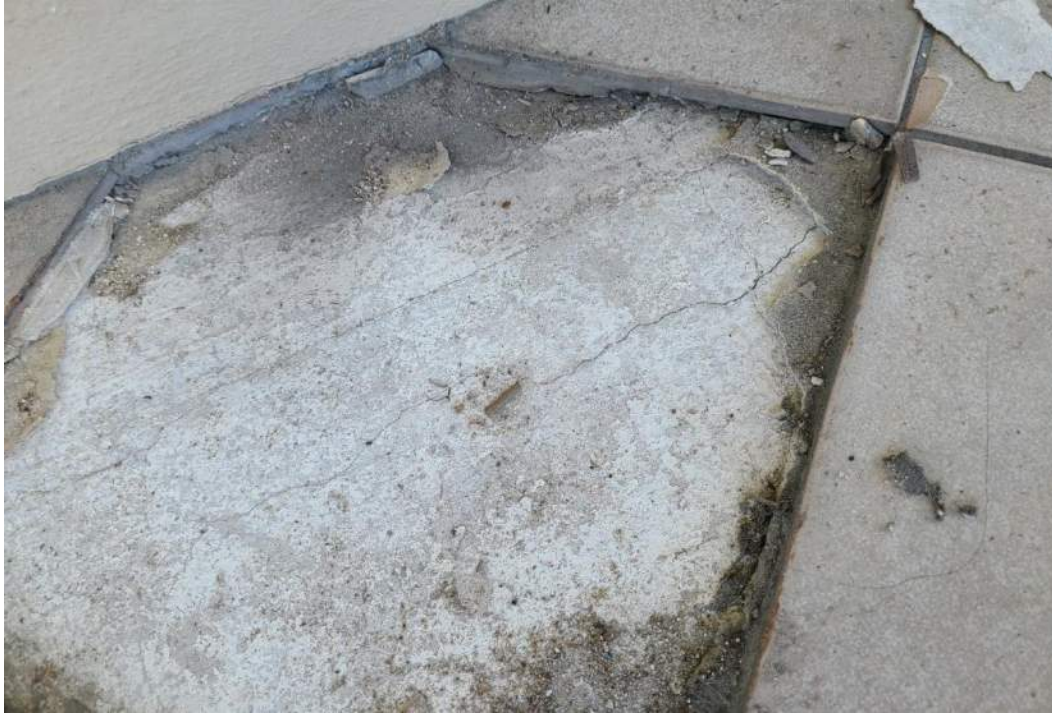
Figure 15. Close-up view of concrete slab cracked and delaminated below tile finish

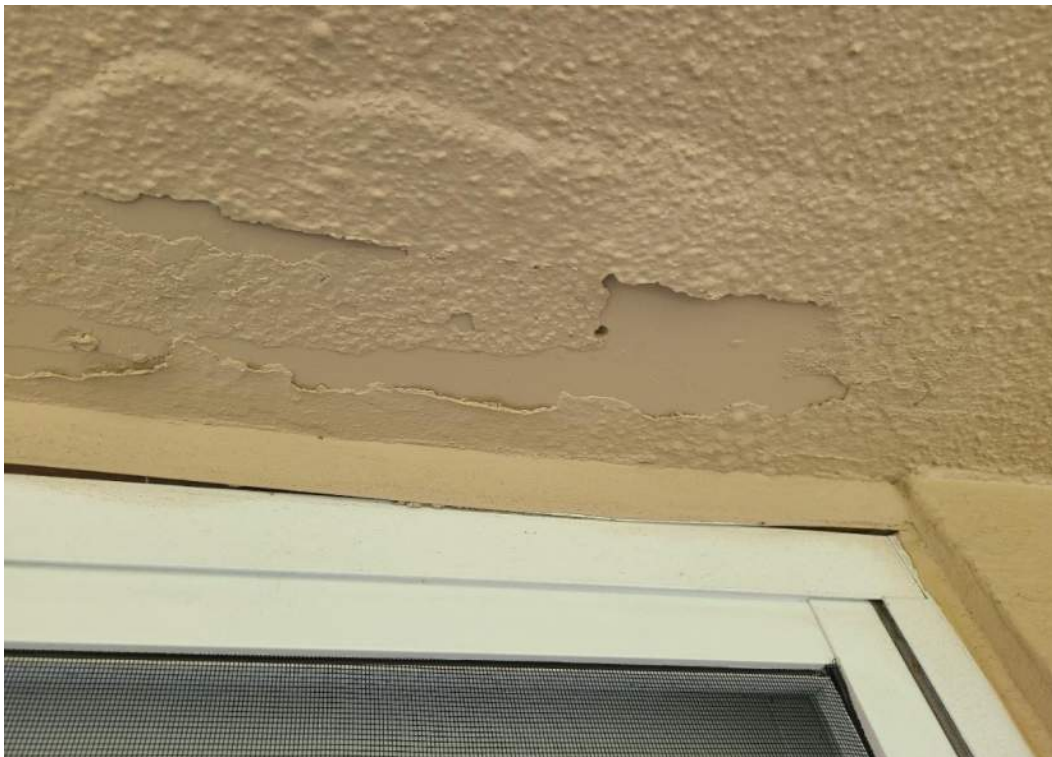
- Approximately 46 occurrences of protective coating failure were observed, totaling approximately 53 sq. ft., were observed on the soffits of the balconies and roof overhangs. Approximately 56% of the coating failure observed on the soffits were located on the south side of the building (Figure 17 and 17).

Figure 16. Coating failure on the soffit.

- Within the next six months (or as soon as feasible) or in conjunction with concrete repairs have a qualified coating installer remove and replace in kind areas of missing, cracked, on debonded/blistered coating.
- Have a qualified coating installer perform annual assessments and local repairs to deteriorated portions of coatings or repair coating in conjunction with concrete repairs
- Budget to have coating systems removed and replaced every 5 and 15 years.

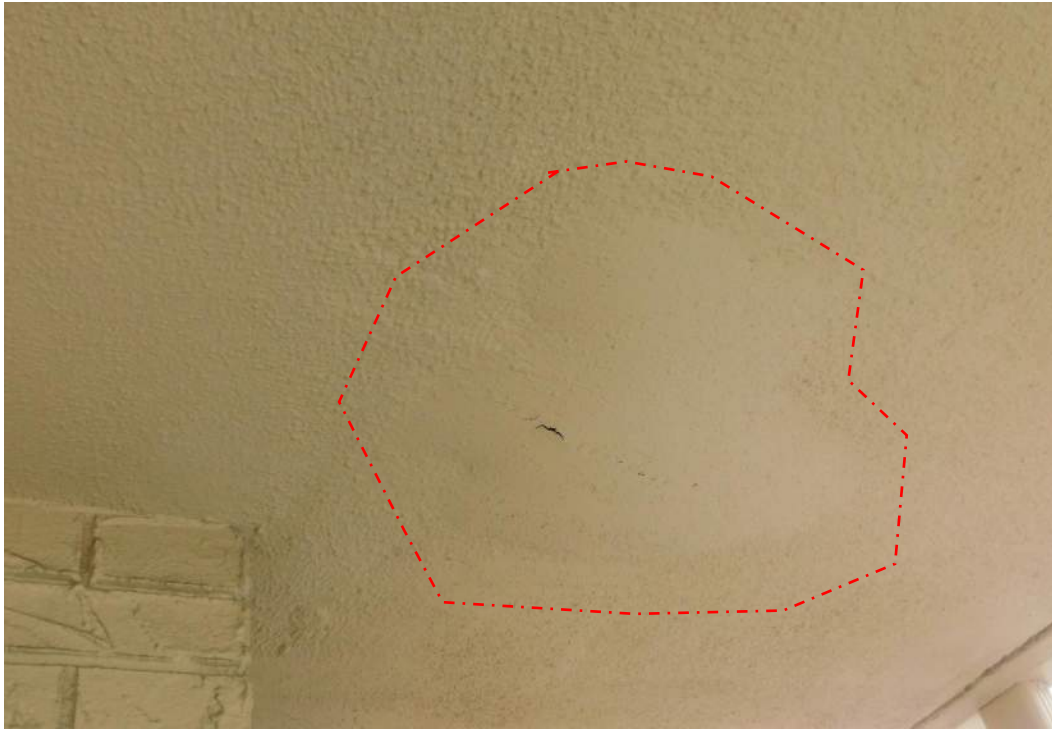
Figure 17. Coating failure (blister) on the soffit.

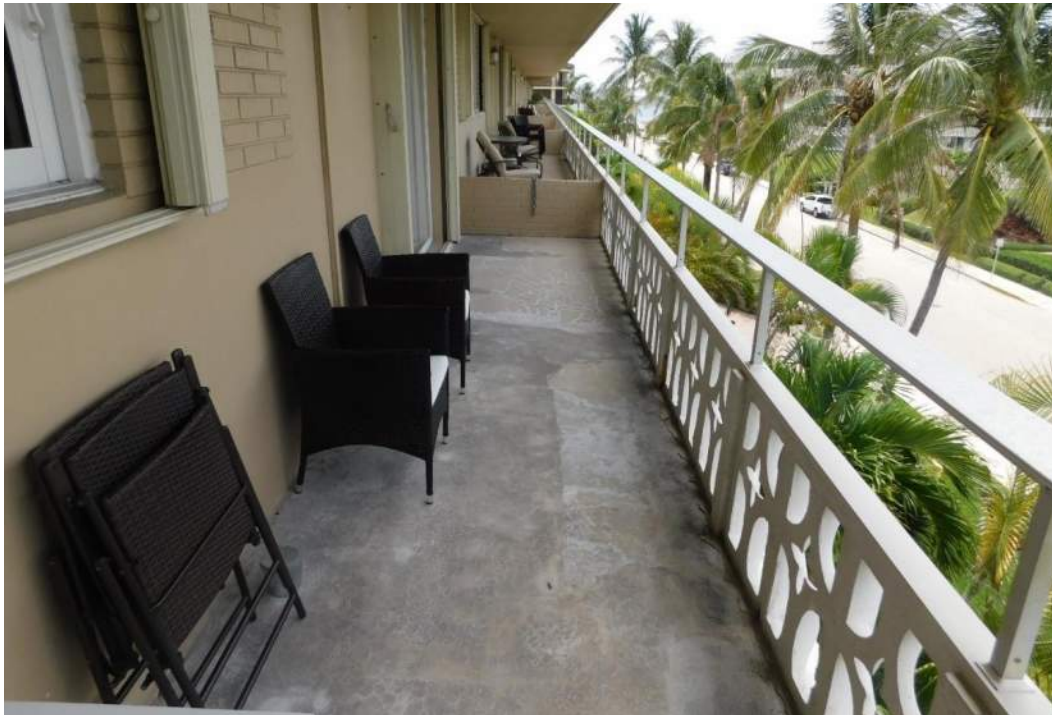
- The coating covering the entire surface of Unit 409 has failed or otherwise been removed, exposing the concrete slab beneath (Figure 18).
- 17 instances of previous repairs, totaling approximately 27 sq. ft., were detected on the soffit across all levels surveyed (Figure 19).

Figure 18. Failed or removed concrete protective coating on deck

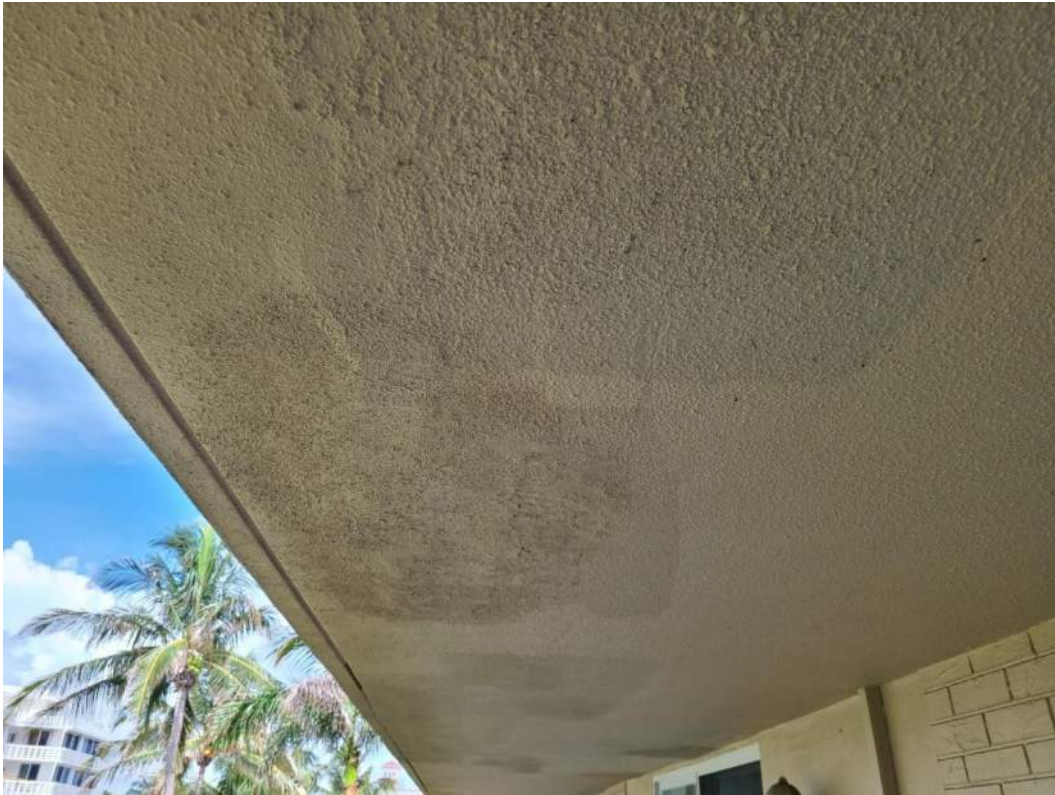
Figure 19. Previous patch repair observed along soffit

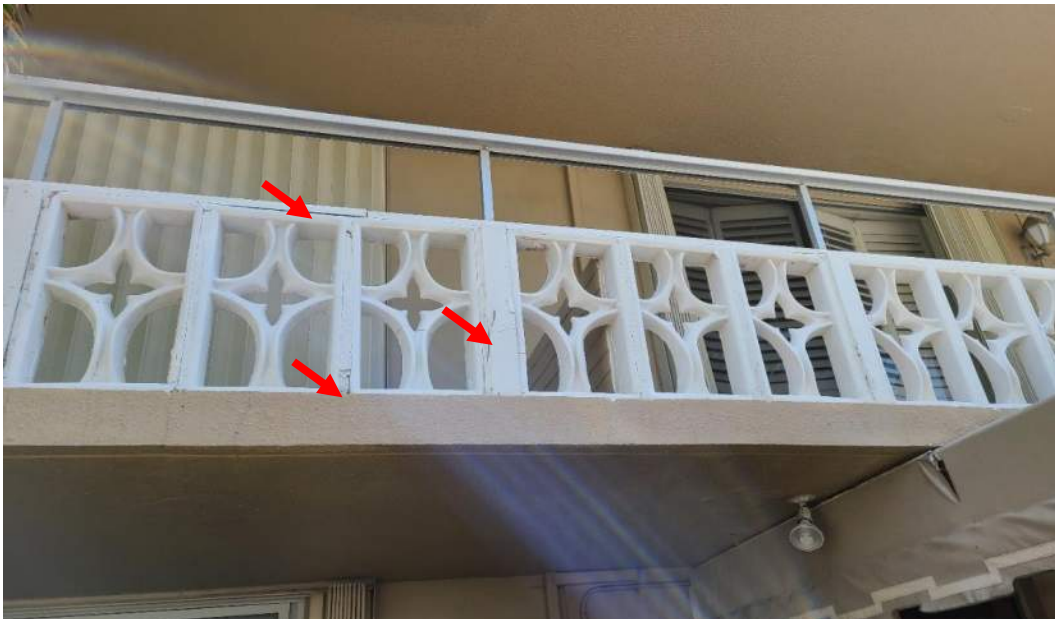
- Delaminated, cracked, and spalled concrete, as well as corrosion stains and exposed corroded reinforcing steel were observed on the precast ornamental inset panels and cast-in-place concrete posts of the balcony guard rails (Figure 20 through, Figure 24).

Similar to the concrete balcony slabs, the distress observed on the balcony guardrails is consistent with corrosion of the embedded reinforcing steel, again likely due to carbonation or chloride ion penetration of the concrete. By far the most prevalent and significant of the distress observed was present in the precast concrete ornamental inset panels. Numerous spalls exposed corroded reinforcing steel that were placed with shallow concrete cover (near surface) within the precast inset panels. In some cases, this shallow cover was observed to be less than one-half-inch. The ornamental design of the inset panels is such that placing embedded reinforcing steel with significant cover is practically challenging due to the relatively thin wall sections of the panels.

Figure 20. Deterioration of precast ornamental guardrail

Option 1 | Replacement of Select Inset Panels

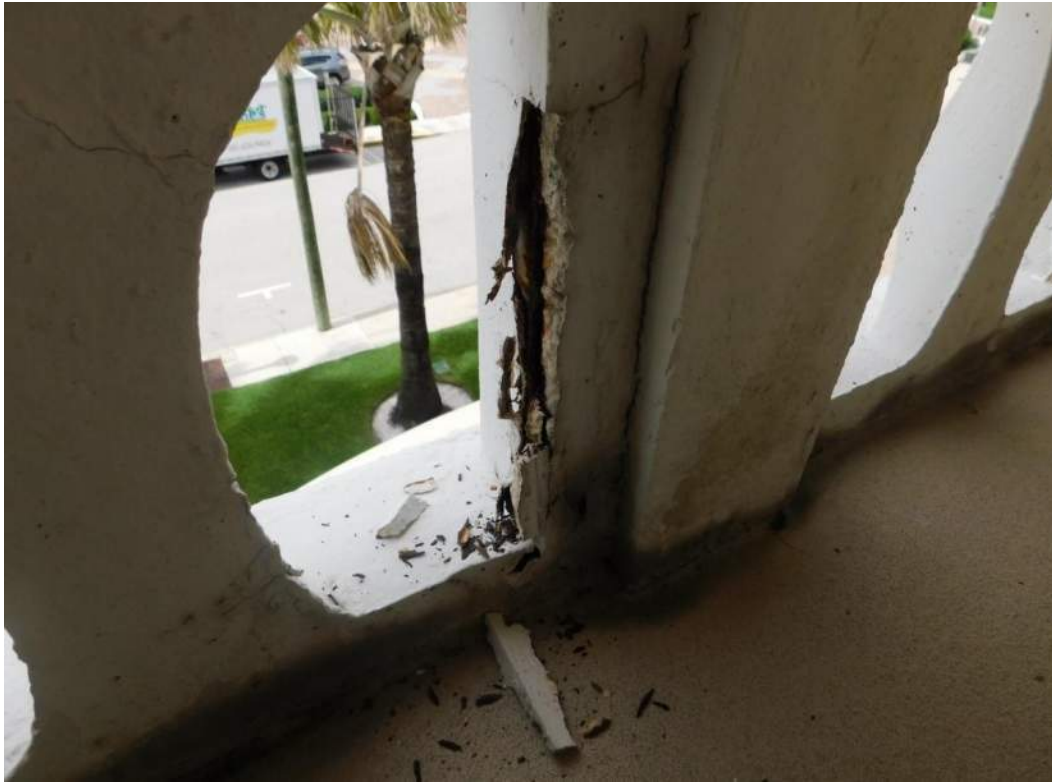
- At locations where the embedded reinforcing steel within the inset panels were exposed due to concrete spalls, WJE observed the concrete cover on the reinforcing steel was typically shallow with several areas of cover observed to be less than one-half inch.

Figure 21. Exposed reinforcement on the precast ornamental panels.

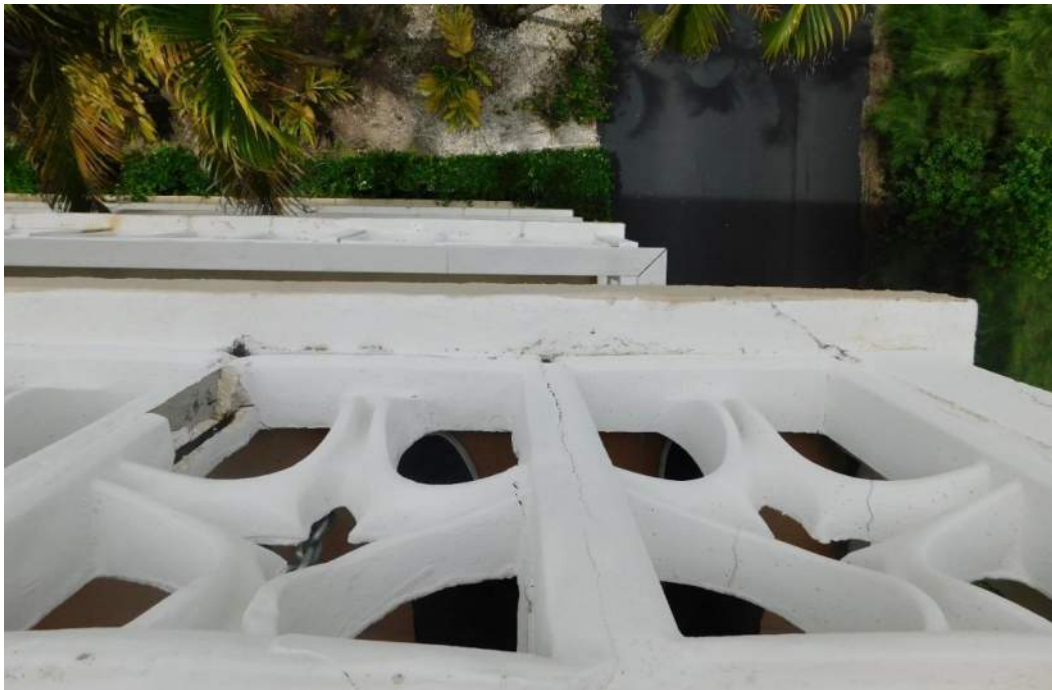
Figure 22. Deterioration of the precast ornamental panels.

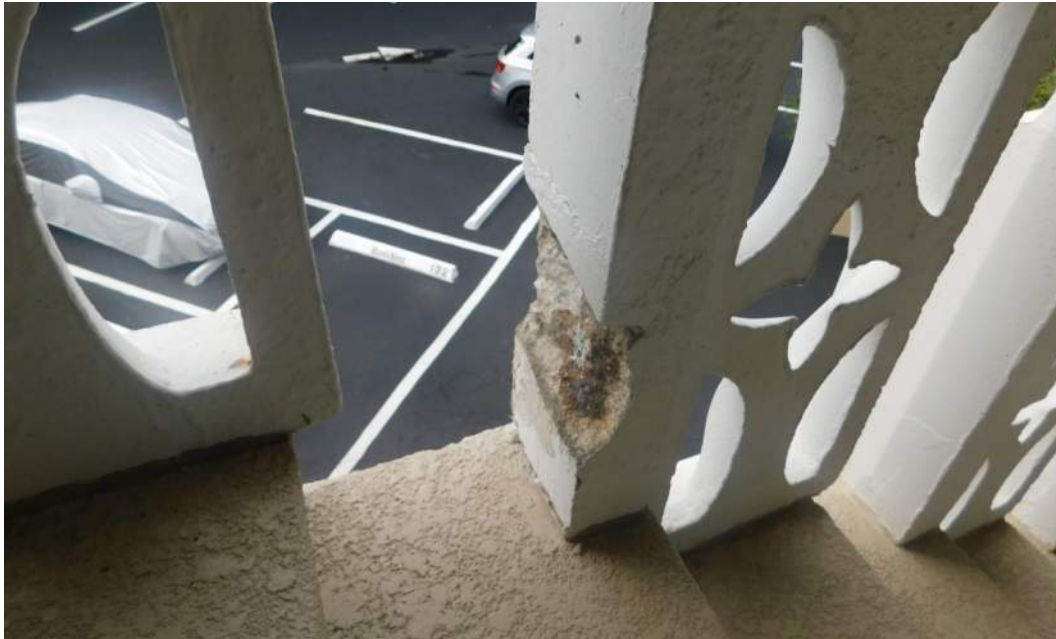
Figure 23. Spalling and exposed reinforcement on the ornamental precast panel

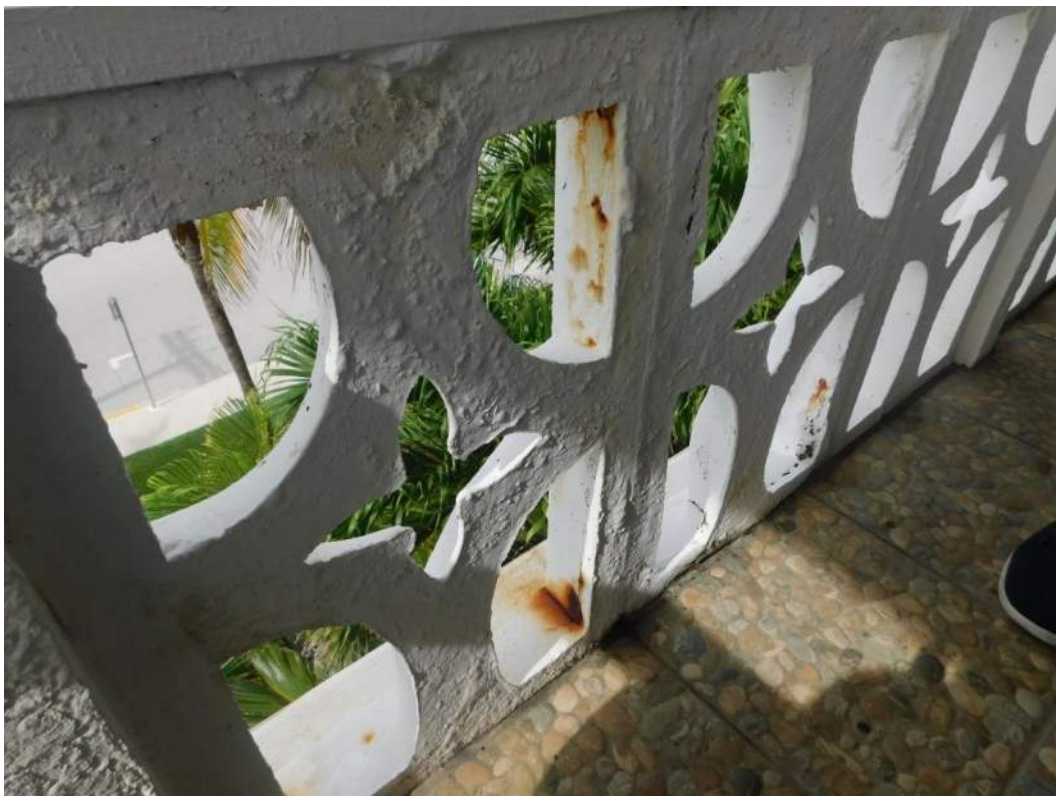
Figure 24. Corrosion staining on the ornamental precast panels.

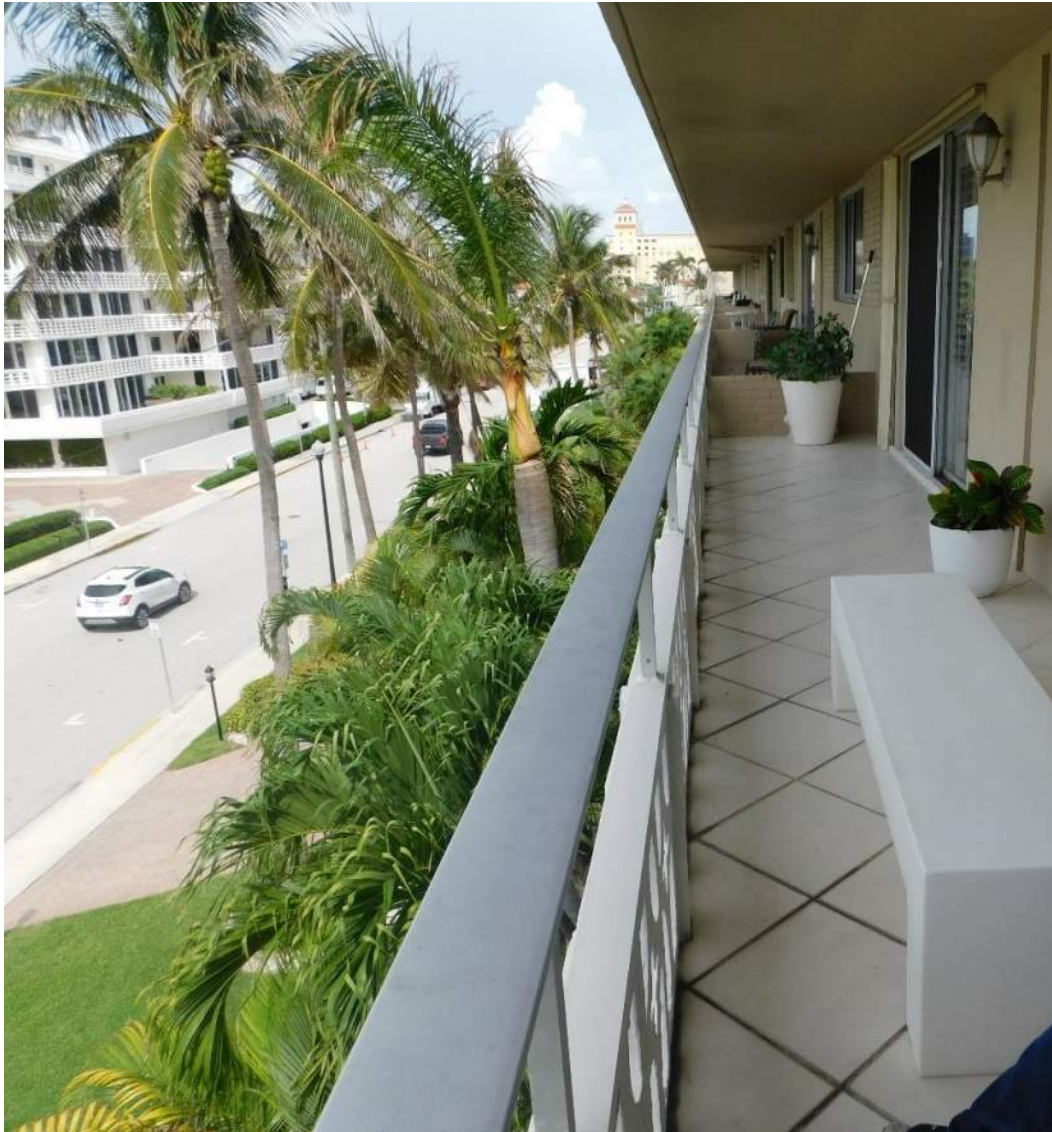
- Damage or deterioration was not observed in the aluminum handrail portions of the guardrail (Figure 25).
- To catalog the approximate extent of distress, WJE enumerated the number of precast panels and concrete posts that exhibited any of the above-mentioned distress. The results of that survey are provided in Tables 3 and 4.

WJE did not identify visible deterioration or distress in the aluminum handrail components of the guardrail. These aluminum components appear to be performing as intended.

Figure 25. Aluminum guardrail
